## Seam Edge Rot Repair

By Sherwood Heggen

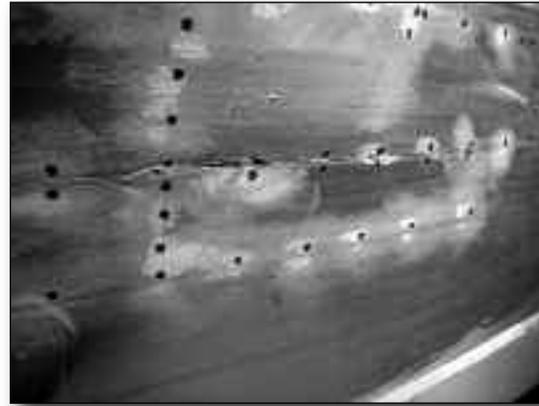
It was a “simple” job I was asked to do, having done it a few times before, and that was to refinish a Chris Craft barrel back. Strip the finish, repair and eliminate the blemishes, stain, and put on a shiny show finish. And by the way, I was to take a look at a couple of planks on the port side. There seemed to be some deterioration at the seam between the first and second planks at mid-ship. Deterioration!? No, after prodding the area with an ice pick, I found a case of pure rot! And, of course, it had to involve two of the most difficult planks on the boat to replace. It was time to think of the best plan of action. With that in mind, this article is offered to get you thinking that there is always an alternate way to fix a small problem rather than tear everything apart and destroy a lot of original parts.

The rot had gone past the planks and into the seam batten behind. The planks would have to be removed, but should the planks be replaced? The rot was localized to a span of about a foot. Beyond that, the wood was hard and appeared normal. To replace the entire plank seemed such a waste of beautiful, original ribbon grain mahogany from the 1930's. Probing into the soft wood, it was easy to confirm the rot was only on the edge of the planks and didn't go very far across the grain. It was such a small area, why not repair the small area instead of replacing two huge difficult to replace planks? A boat of this character must be handled with a lot of consideration. There are too many botched repair jobs out there. There is no need to add to the number. So, the goal was to make a patch, make it blend into the existing wood, and retain as much original wood as possible. That is quite an order to fill! Where to start!?

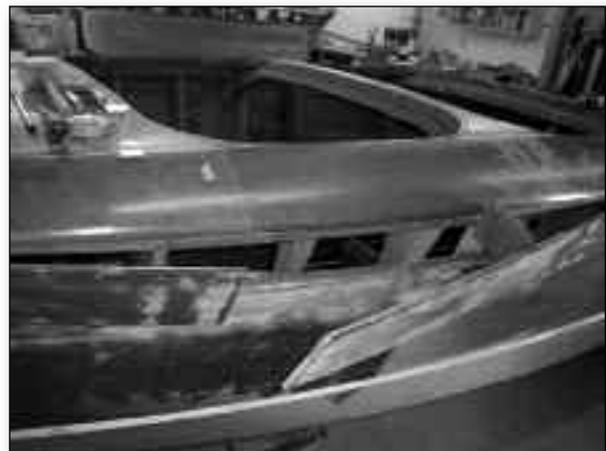
Did the entire planks have to be removed? Certainly not. It was only necessary to loosen the planks in the area which required repair plus a little more for wiggle room. But before doing that, the fair line of the plank seam should be retained. To do that, tape a piece of masking paper over the affected area and rub the side of the pencil lead against the seam area. This will give a defined seam line to use as a reference to retain the seam line. Before removing the paper, establish a reference mark on the boat and paper to be able to reposition the paper after it has been removed to accomplish the repair. The paper will be cut in two at the seam line to trace the new seam line on each repaired plank.

Now it is time to loosen the problem planks. Get out the ice pick and screw gun and remove the bungs and screws. Loosen the planks as far as necessary to pull the planks away from the hull to allow working room.

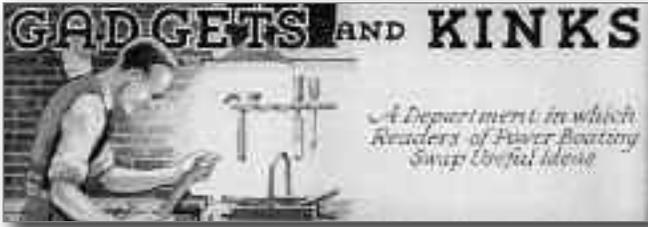
Removing the rotted batten could be a problem, but the right tools always make the job so much easier. In this case the right tool is a Makita circular saw with a three inch blade. Set the blade cutting depth to the thickness of the batten and cut it alongside the frames. The pieces between the frames will fall out and the parts in the notches of the frames will still be firmly in place held securely with a nail. Since the planking is restricting access to the nail, it will have to be removed from the inside of the boat. Take a chisel and split the batten stub in the middle where the nail likely is and then knock it loose with a hammer. All that will remain is a nail. If space allows, it can be removed with a pliers, or simply saw it off with a hand held hack saw blade. Now measure to size and wiggle in a new batten. Install short batten blocks over the batten ends to make a continuous batten and secure with some screws as show in the picture below.

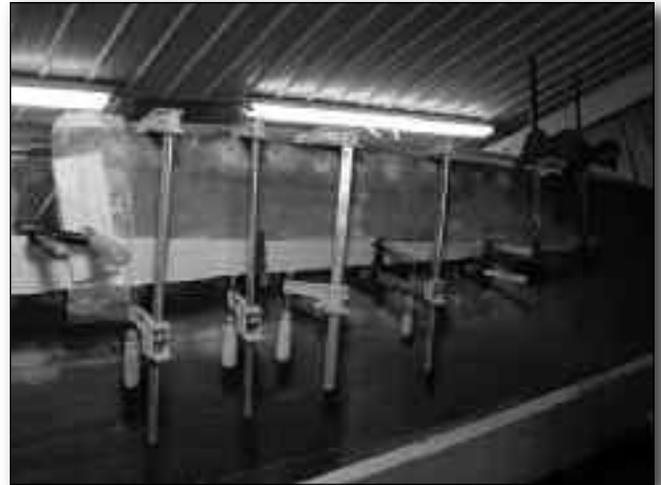
With the affected frame members replaced, it is time to remove the rotted edge on the planks and replace it with new wood. This will be an exercise in grain and wood color matching. Luckily, the line of the grain on the original plank had a slight upward angle to allow a long wedge to be removed in the rot area. A piece of wood was chosen with similar color and straight grain. A line was drawn with a straight

edge and black ball point pen on the original plank in line with the grain for the cut line. The ball point pen is used rather than a pencil because the pen line is far more visible than a pencil line. The bad wood as removed with a saber saw and an edge plane is used to trim to the line. The replacement piece was cut a bit over size to allow trimming to exact size. Try to match the grain on the replacement piece with the grain on the original plank where the edges join. Glue and clamp the new piece in place with Titebond III.

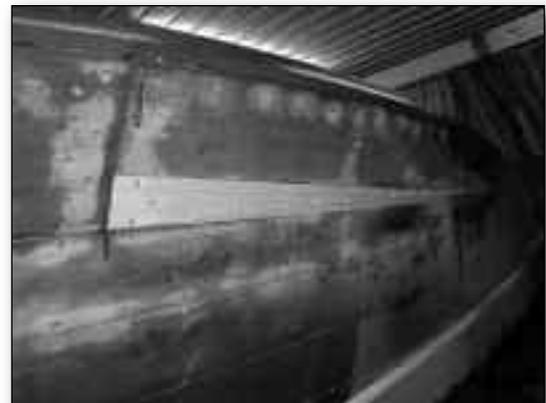
Remember the tracing of the seam made on paper earlier? That paper is now taped in place according to the reference marks placed on the original plank and the paper. This will allow a marking of the original seam line again with a black ball point pen. Remove the excess carefully to the line with an edge plane. Do the same with the other plank after the new piece is installed. Some fitting will have to take place. Sneak up on the fit with an edge plane to provide a relatively tight seam. Once the fit is good, screw everything in place, sand the new wood fair to the old. Install and trim the bungs flush, do the final sanding and apply the new finish.

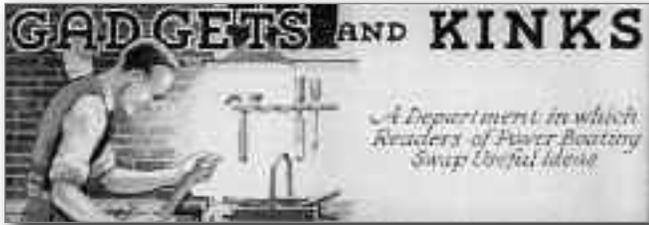
With the subject boat, a full strip, stain, and varnish will take place so there won't be a problem with blending the old and new finish. If the whole boat is not to be stripped, it would be a good idea to tape off and strip at least the affected planks and refinish them. Trying to blend a patch area into original stain and varnish is difficult at best to create a seamless finish.
