# GADGETS AND KINKS

## MAKING NEW QUARTER RAILS

### HOW HARD CAN IT BE?

by Sherwood Heggen

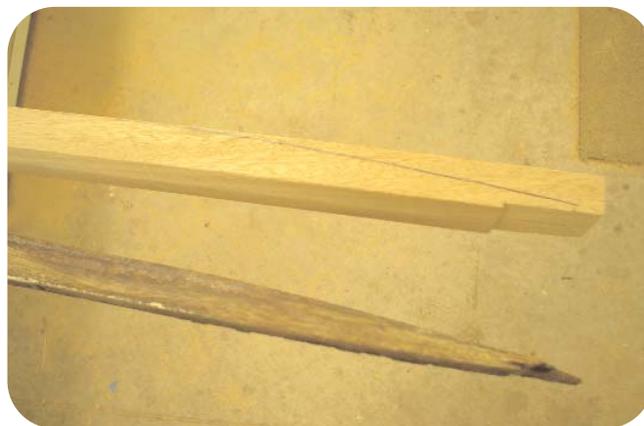
the ridge under the stainless steel trim. This is done by cutting a rabbet on each side of the stock to leave a ridge in the center with a dimension same as the original. Using the original quarter rail as a pattern, draw the curve on the side of the new stock as seen in the picture below, then cut it to shape on a band saw. Finally, cut the tapered sides with a table saw.

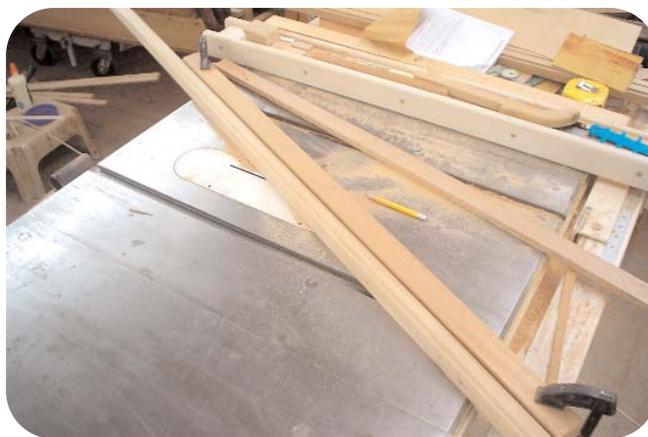
Now look at the backside of the original quarter rail and you will see it is slightly hollowed out leaving an eighth-inch wide edge on either side. This is so the quarter rail fits snugly to the slightly curved hull. Unless you have a shaper and a bit specific to the size for the hollowed area, an alternate tool must be used, and that would be a table saw. To do this, the stock must be run through the table saw at an angle as shown in the picture below.

The table saw must be set up accurately to get the correct depth and width of the hollow. To assist in getting things right, cut a length of scrap lumber to the same width

as the quarter rail as a test piece. Raise the blade to cut the correct depth of the hollow. Remove the fence from the saw and replace it with a straight length of scrap lumber clamped at both ends to the saw at an angle as a temporary fence. The position of the fence will center the cut on the stock and its angle will determine the width of the saw cut. The greater the angle to the blade, the wider the cut. Adjust the angle and position of the temporary fence until the cut on the scrap stock matches that of the original quarter rail. When the cut is correct, it is time to run the actual stock through the saw. But wait! The cut does not start and stop at the end of the stock. It starts and stops about six inches from the end. So, mark on the stock where those points are and also on the fence where the starting and stopping points should be. Make the cuts and hold the new quarter rail to admire your skills. Take some sandpaper after it to eliminate saw marks, drill the holes for the screws which will hold it to the hull side. Apply the stain and varnish and screw 'em to the hull. Done.
